# Manhole Inspection Summary

Manhole # S15KK1014MH

Insp Date: **12/5/06 2:47 PM**

**Location** Address: **2808 EDGECOMBER CIR**

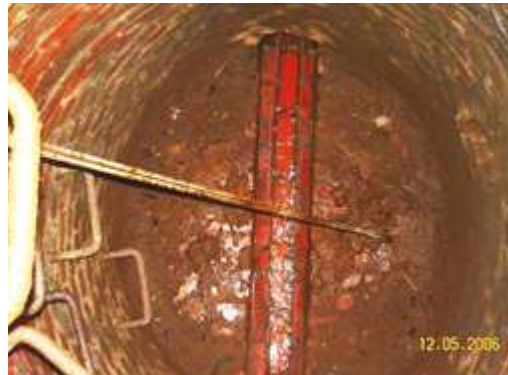
Top View

Evidence of surcharge - Bench debris.  
Corroded steps.

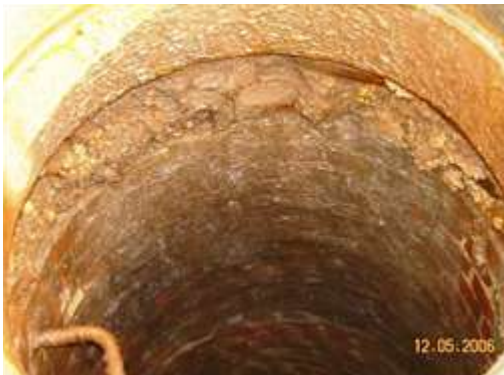
Defect

Frame leaks. Adjustment deterioration  
and infiltration. Barrel infiltration.

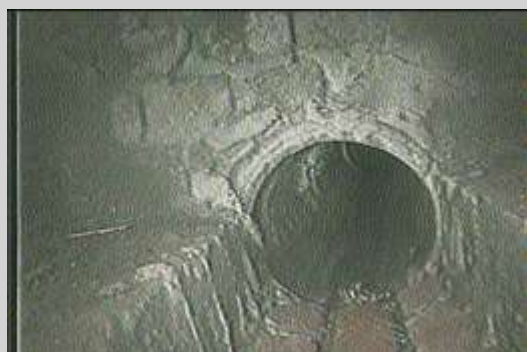
Pipe Out @ 12 O'Clock

Infiltration: **Evidence** Pipe Seal Cond: **Cracked**
